Manhole Inspection Summary

Manhole # S29CC_044MH

Location Address: **1230 STODDRAD ST**

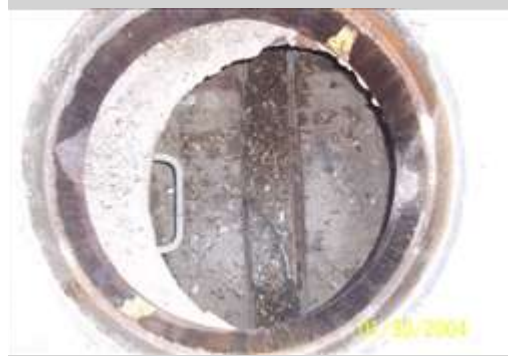
Top View

Bench and Channel debris.

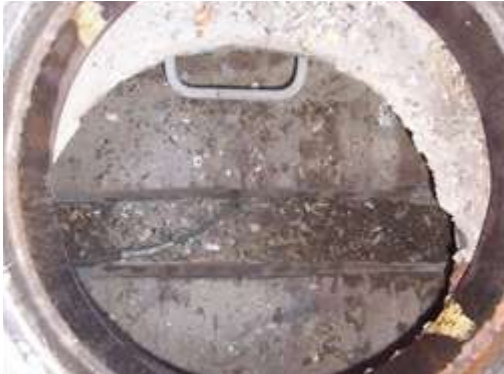
Defect

Frame Offset: **6** (in.) Condition: ☐ Sound ☐ Cracked ☒ **Leaks**

Frame leaks. Frame offset.

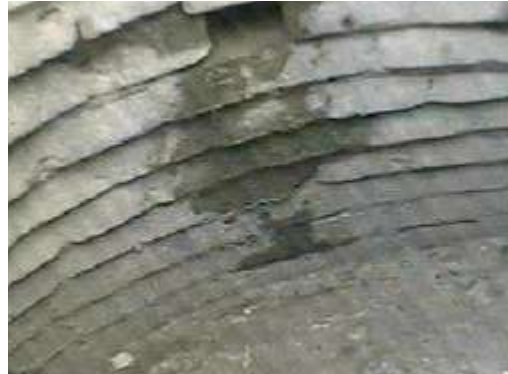
Defect

Comments **Missing brick in wall allowing infiltration.**

Missing brick on wall allowing infiltration.

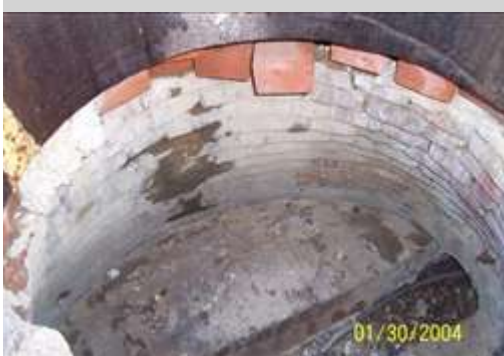
Defect

Condition: ☐ Sound ☐ Cracked ☐ Root Intrusion ☒ **Loose Brick** ☒ **Deteriorated**

Infiltration: ☐ None ☒ **Joint** ☐ Cracks ☒ **Mortar** ☐ Roots ☐ Wall

Infiltration: ☐ None ☐ Joint ☐ Cracks ☐ Mortar ☐ Roots ☒ **Wall**

Adjustment loose bricks, deterioration and infiltration. Corbel infiltration.

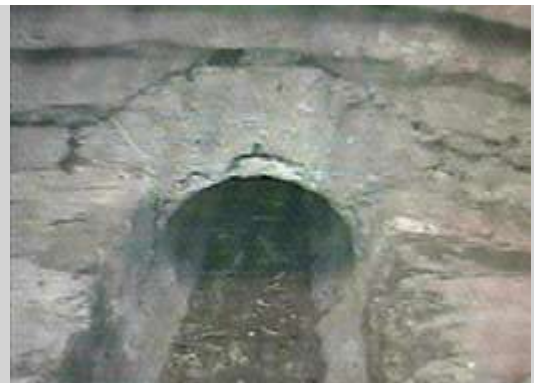
Pipe Out @ 12 O'Clock

Deposits: ☐ None ☒ **Mud** ☐ Sludge ☒ **Debris** ☐ Grease

Silt Depth: **0.5** (in.) Deposits Extent: **Light**

Infiltration: **None** Pipe Seal Cond: **Cracked**

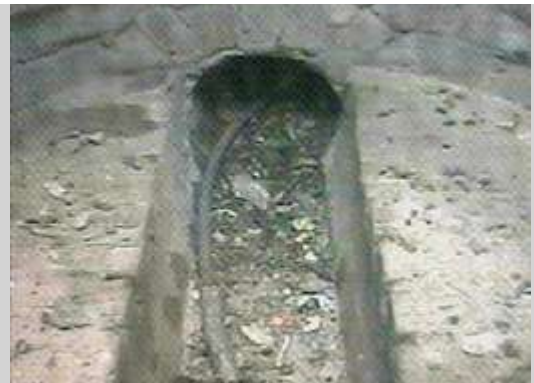
Pipe In @ 6 O'Clock

Deposits: ☐ None ☒ **Mud** ☐ Sludge ☒ **Debris** ☐ Grease

Silt Depth: **2** (in.) Deposits Extent: **Light**

Infiltration: **Evidence** Pipe Seal Cond: **Cracked**
